Manhole Inspection Summary

Manhole # S49OO_010MH

Insp Date: **5/13/08 12:36 PM**

Location Address: **Elmora ave**

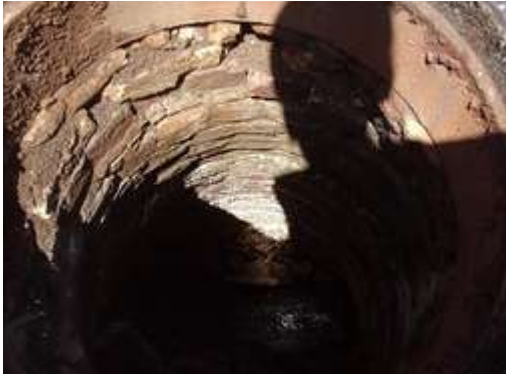
Defect 1

Condition: ☐ Sound ☐ Cracked ☐ Root Intrusion ☒ **Loose Brick** ☐ Deteriorated

Infiltration: ☐ None ☒ **Joint** ☐ Cracks ☒ **Mortar** ☐ Roots ☐ Wall

loose bricks

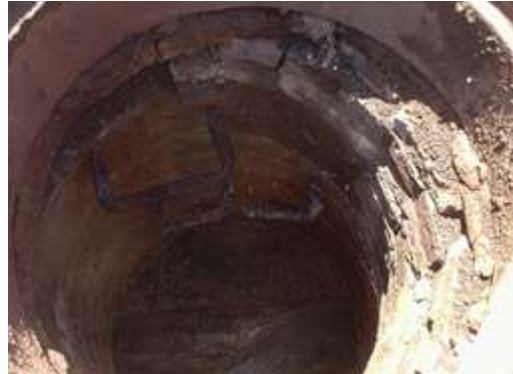
Defect 2

loose bricks

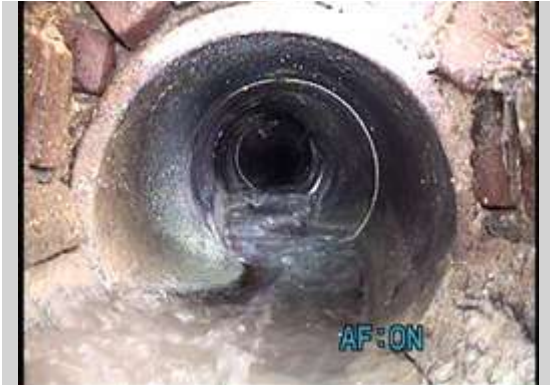
12 O'Clock Outflow

Pipe Height: **12** (in.) Rod and Bar (Angled)
Pipe Material: **Clay** ☐ Pipe Lined
Invert Depth: **9.20** (ft.) Flow Characteristics: **Fast**
Deposits: ☒ None ☐ Mud ☐ Sludge ☐ Debris ☐ Grease
Silt Depth: (in.) Deposits Extent:
Infiltration: **None** Pipe Seal Cond: **Sound**

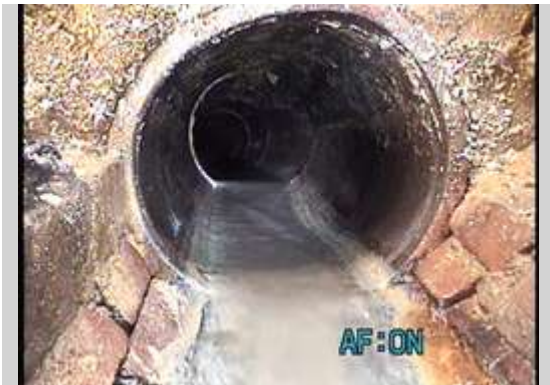
4 O'Clock Inflow

Pipe Height: **12** (in.) Rod and Bar (Angled)
Pipe Material: **Clay** ☐ Pipe Lined
Invert Depth: **8.80** (ft.) Flow Characteristics: **Fast**
Deposits: ☒ None ☐ Mud ☐ Sludge ☐ Debris ☐ Grease
Silt Depth: (in.) Deposits Extent:
Infiltration: **None** Pipe Seal Cond: **Sound**

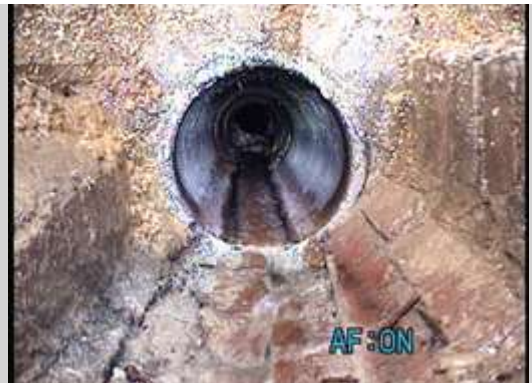
6 O'Clock Inflow

Pipe Height: **8.4** (in.) Rod and Bar (Angled)

Infiltration: **None** Pipe Seal Cond: **Sound**
